# **Love Your Lake**

## **Blackstrap Lake, Saskatchewan**

Written By: South Saskatchewan River Watershed Stewards Inc.

November 2016

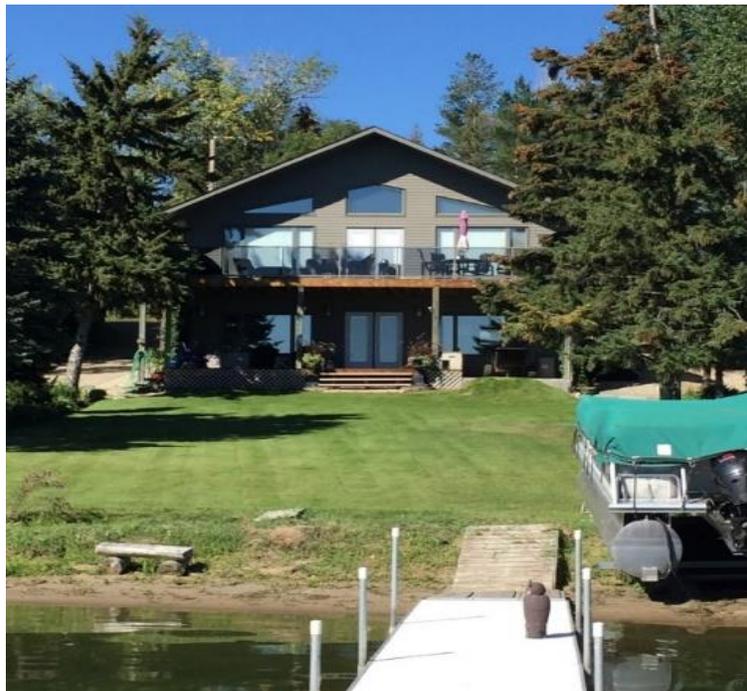
Photo 1. Ornamental shoreline at Resort Village of Shields

In conclusion, the majority of Blackstrap Lake's shorelines have been altered from their natural state, therefore our plans for next year include naturalization projects through the Natural Edge Program developed and coordinated by the Canadian Wildlife Federation and Watersheds Canada. The South Saskatchewan River Watershed Stewards also have plans to work with these

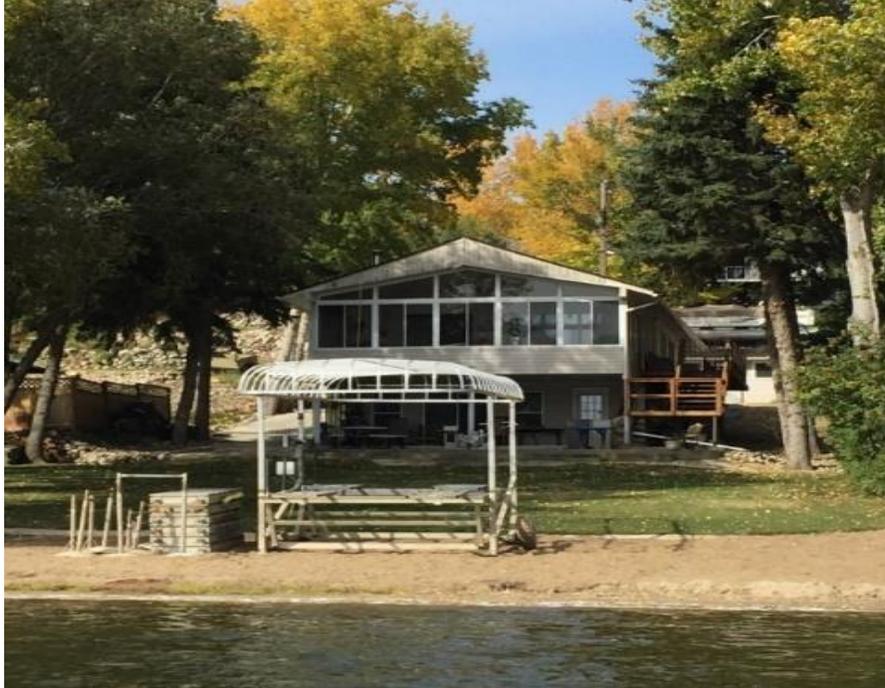
Based on the Blackstrap Lake shoreline assessments it is evident that majority of the cottage front shorelines are ornamental with few buffer zones. The shoreline assessments revealed degradation of the shorelines are due to cottage developments and severe shoreline erosion. Both of the resort villages have sections of the shoreline that have been lost due to severe erosion. At the Resort Village of Thode there are naturally sandy shorelines that have resisted erosion. Photo 1 illustrates a property that does not have a buffer zone and the shoreline has been compromised with planted ornamental grass. Photo 2 illustrates a property that has a naturally sandy shoreline. This shoreline does not show any signs of erosion. Photo 3 is an

Photo 2. Naturally sandy shoreline at Resort Village of Thode

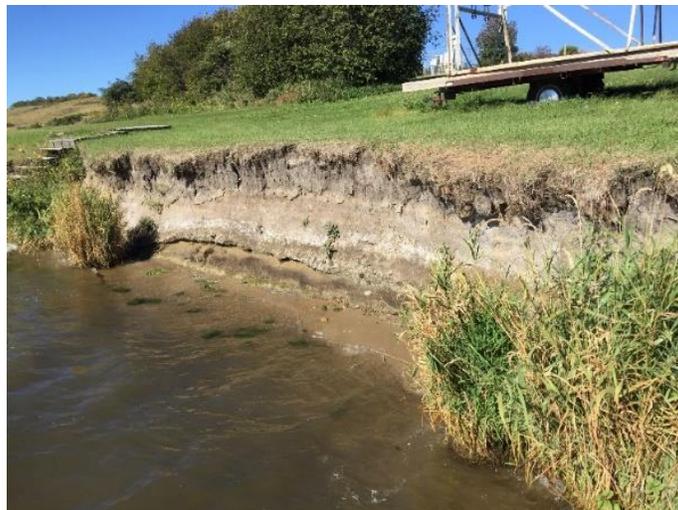
example of how severe the shoreline loss is at the Resort Village of Thode. It is a visual representation of how rapid the shoreline loss has been over time.

Photo 3. Shoreline loss at Resort Village of Thode
