Saskatchewan
Watershed
Authority

Health of Riparian Areas in Southern Saskatchewan

FACT sheet

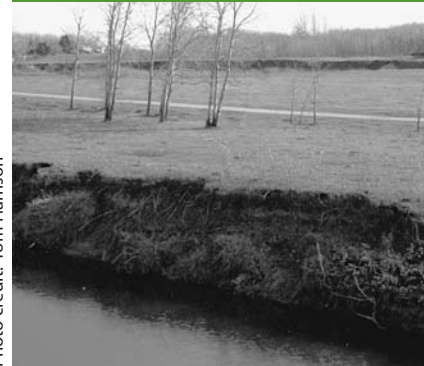
Disturbance species are unable to prevent soil and bank loss.

Herbaceous (non-woody) vegetation along riparian areas is also very important. Typical riparian plants such sedges and rushes can become replaced with less desirable plants called disturbance species. Disturbance species generally have shallow root systems and cannot function to prevent soil and bank loss. Seventy five percent of riparian areas had disturbance species such as Kentucky blue grass, smooth brome and sow thistle. Also of concern are many noxious weeds which tend to invade and take over riparian areas. These invasive species such as Canada thistle or leafy spurge were found on 54 percent of sites.

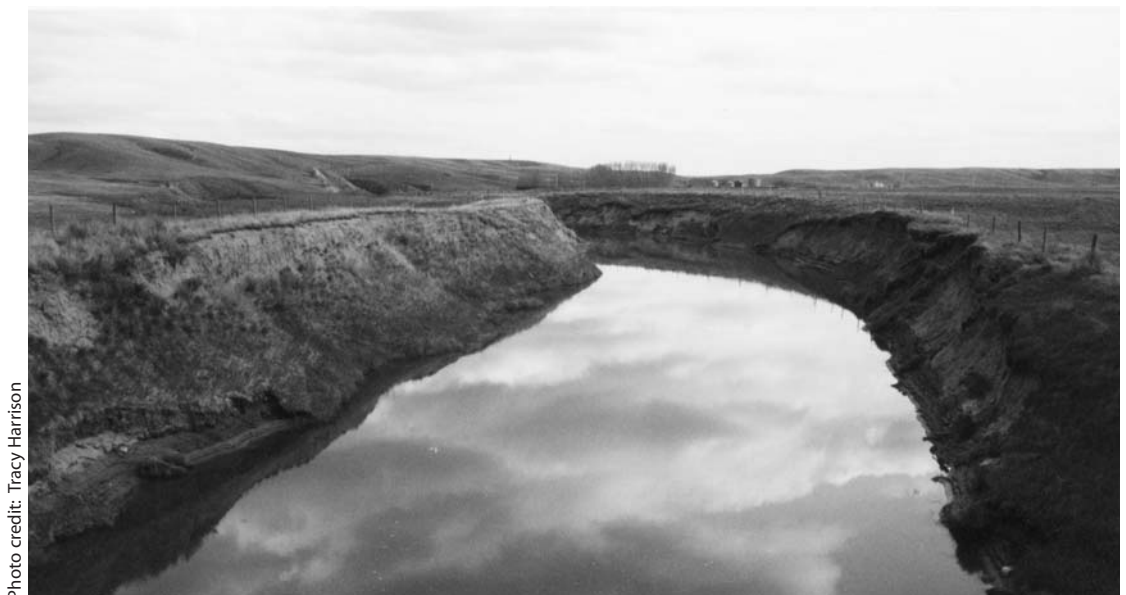
Incised rivers are unable to reach their floodplain.

A healthy riparian area is one which can perform the essential functions of flooding, slowing of water and ground water recharge. When a system has down cut and has a reduced ability to flood out of its banks the creek is said to be incised. Seventy four percent of streams and rivers had some degree of incisement. Water management, bank instability and channelization can cause this problem. Another important indicator of a healthy riparian area is the balance between erosion and deposition. Creeks and rivers naturally cut on the outside edge of curves and deposit on the inside of curves. If a greater proportion of the creeks are laterally cutting, excess sediment is being added to the system resulting in a decrease in water quality. Seventy percent of streams showed excess lateral cutting.
